# Manhole Inspection Summary

Manhole # S31GG\_033MH

Insp Date: **1/16/07 10:08 AM**

**Location** Address: **212 BOLTON PL**

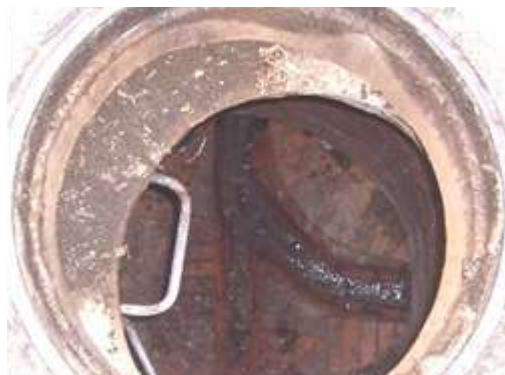
Top View

☐ Parged ☒ **Debris** (not Condition related)

☒ **Debris** (not Condition related)

Bench and Channel debris.

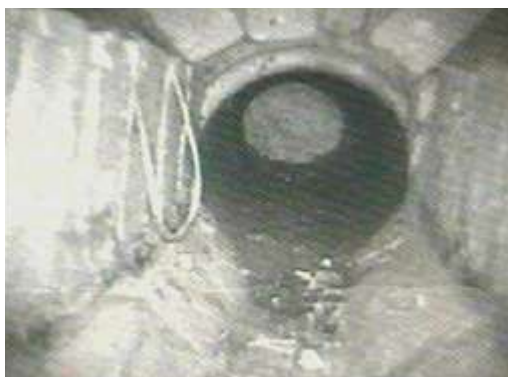
Inside the I6

Plugged.

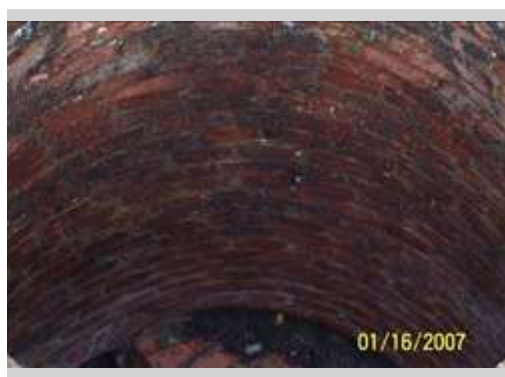
Defect

Infiltration: ☐ None ☐ Joint ☐ Cracks ☒ **Mortar** ☐ Roots ☒ **Wall**

Corbel and Barrel infiltration.

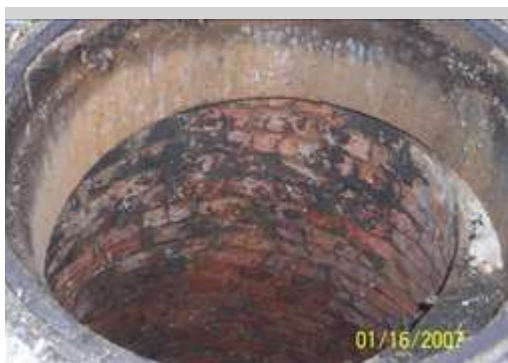
Defect

**Frame** Offset: **4** (in.)

Infiltration: ☐ None ☒ **Joint** ☐ Cracks ☒ **Mortar** ☐ Roots ☐ Wall

Frame offset. Adjustment, Corbel and Barrel infiltration - other side.

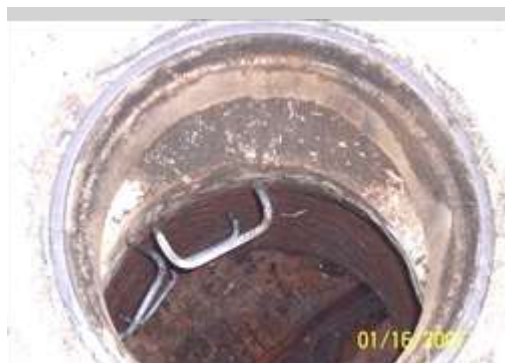
Defect

Frame offset. Adjustment, Corbel and Barrel infiltration.

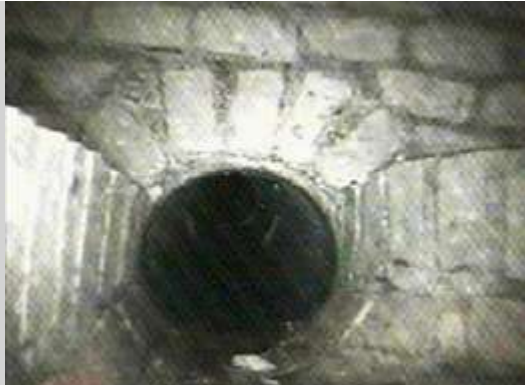
### 8 in. Circular Gravity Sewer Pipe Out @ 12 O'Clock

Infiltration: **Evidence** Pipe Seal Cond: **Unknown**

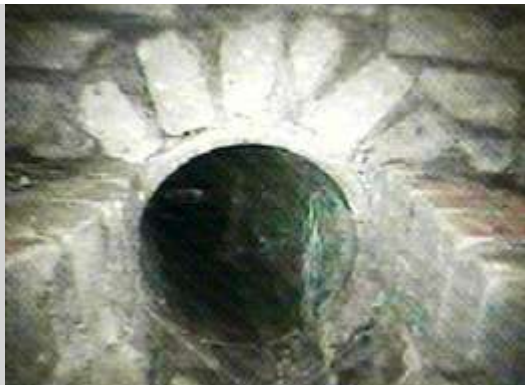
### 8 in. Circular Gravity Sewer Pipe In @ 3 O'Clock

Infiltration: **Evidence** Pipe Seal Cond: **Cracked**

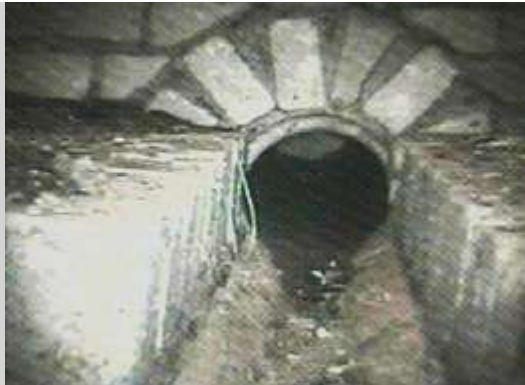
6 in. Circular Gravity Sewer

Condition: ☐ Sound ☐ Cracked ☐ Root Intrusion ☒ **Deteriorated** ☐ Leaks ☐ Debris

Channel deterioration.

Infiltration: **Evidence**
